International Conference on Sustainable Sanitation: "Food and Water Security for Latin America"

RESULTS OF AN EVALUATION OF ECOLOGICAL SANITATION PROJECTS IN THE PERI-URBAN SETTLEMENTS OF LIMA/PERU

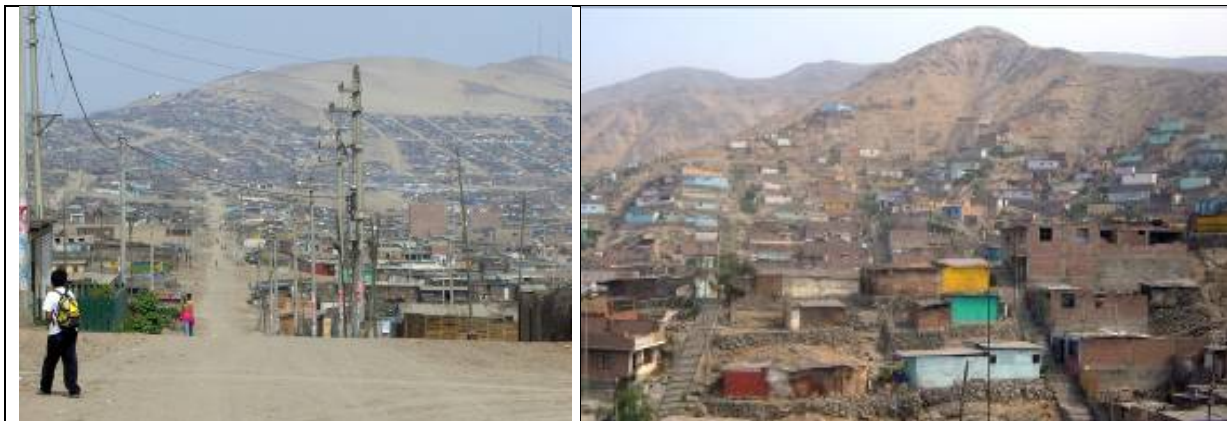
Figure 1: Nueva Pachacútec and Húascar, suburbs of Lima without water supply and installation of some "dry sanitation systems" (dehydrating toilet with sand filter for urine and greywater)

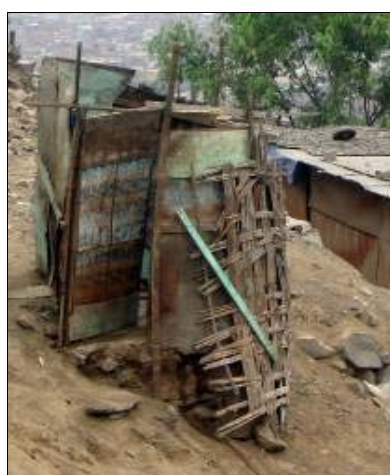
In AHs that are not connected to the public sewage system of SEDAPAL, the most common type of sanitation service are very basic latrines, called *silos*. Those *silos* (Figure 2) do not provide effective health protection, provoke strong smells, are a breeding place for flies, contaminate the ground water and proved to be unsuitable for the urban and peri-urban settlements with high population densities. Many people do not even have silos and have no other choice than to defecate in the field or to discharge the excrements in plastic bags together with the garbage on the roadsides. The greywater is usually spilled onto the streets or is used for irrigation of small flower gardens. CONAM (2005) estimated that in Lima in 1997, 4.24 million cases of diarrhea were caused by deficient water and sanitation services.

Figure 2: Public toilet, one of the usual sanitary "solutions" in the peri-urban AHs of Lima

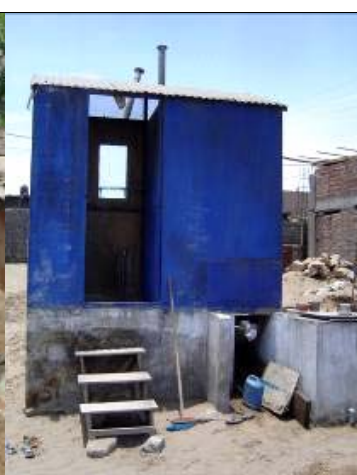
Figure 3: Two chambers dehydration and urine separating toilet

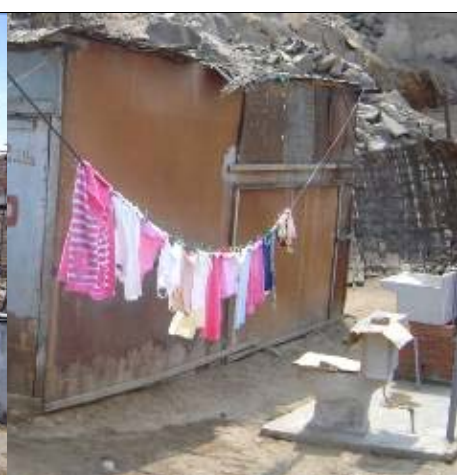
Figure 4: Preparation for connection to the water supply. As in this case, nearly always the water flush toilet is preferred.

of the interviews in February 2007, almost all users had already bought and installed water lavatories and were impatiently waiting for their connection (Figure 4).

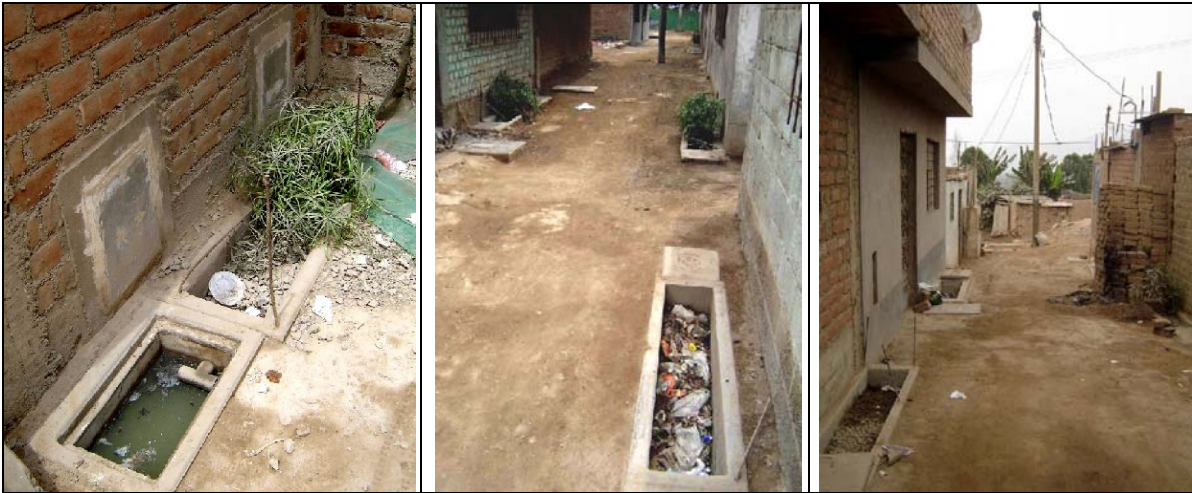
Figure 5: Deficient and no maintained sand filter in Nievería

- The always installed urinals were hardly used.
- The situation of the sand filter unit was disastrous in all project locations.

The non-usage of urinals could be a cultural acceptance problem, but a better understanding and above all a better function of the sand filter unit would certainly help to overcome those problems (Figure 5). In Húascar, no sand filter was used anymore, and in Nueva Pachacutec, the situation was similar. At places, where the water was not used for irrigation, the effluent seeped into the sandy ground next to the houses without any control or was spilled on the dirty roads. But even in Nievería, only 20% of the implemented sand filters were covered with plants on more than half of their area, while 38% had no plant cover at all but just consisted of gravel. The other 18% were completely out of use, with drastic hygienic consequences for the user and their neighborhood.

On the one hand, the reason for this situation can be found in technical problems, like limited dimensions of the sandfilter, missing distribution systems and high concentration of urine due to too little water consumption, causing soil clogging, dying of plants and problems with odor and mosquitoes. On the other hand, it is obvious that maintaining work, like replacement of died plants, was more than most users could or would handle.

- Technical improvement, especially of the design of the sand filter/constructed wetland
 - Separation of urine and greywater for less complicated treatment
